Common defects that may occur during automotive lens molding

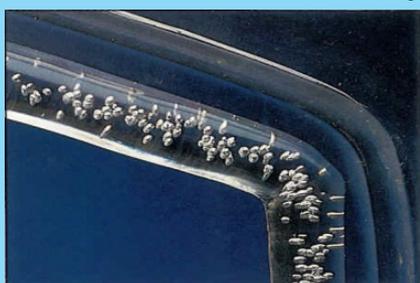
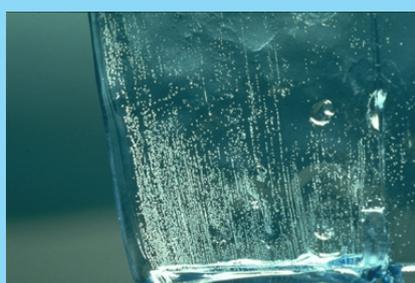
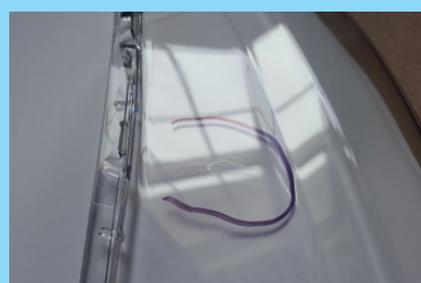
Splay

This defect can range in appearance from tiny bubbles or streaks on the lens surface, typically caused by insufficient drying, to larger individual defects, typically caused by such things as air entrapment in lens features, flow disturbances during filling, material shear heating during filling, material overheating in the molding machine barrel and/or hot manifold system, etc.

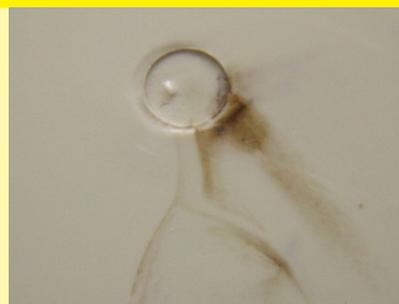
Burning

This defect can appear as brown swirls near a valve gate or hot drop location, which means there is usually material hang-up/degradation occurring near the tip of the drop. It can appear throughout the molded lens, indicating there is likely something in the barrel, nozzle, or manifold system causing material hang-up/degradation.

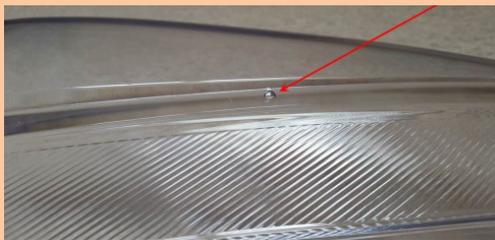
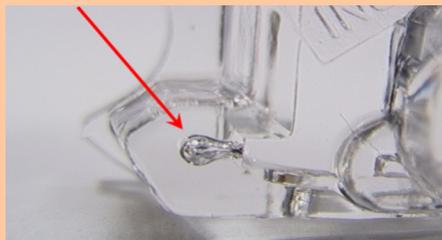
Bubbles in thick sections

Larger bubbles that form in thick wall sections, especially when they are far away from the gate or where the thick wall section is being filled by a thinner wall section, are shrinkage voids that form as the melt is cooling and solidifying. This is actually a part design defect. Every effort should be made to maintain a consistent wall thickness throughout the entire lens to avoid formation of these defects.

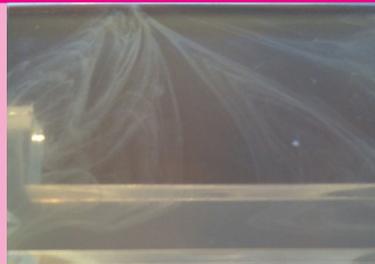
Cloudy swirls

Milky-white cloudy swirls in the molded lenses are typically caused by contamination from foreign materials. This could range from pellets of a different type of material getting mixed in with the clear PC pellets to pieces of the box liner bag that get torn and mixed in with the clear PC pellets. In either case, a review of pellet handling procedures should be conducted and corrective action implemented.

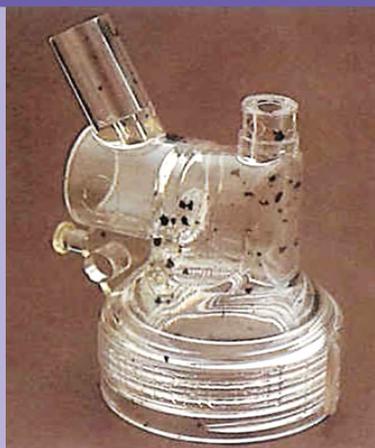
Black Specks

While molding automotive lenses using Makrolon® polycarbonate over extended periods of time, a layer of carbonized material forms inside the molding machine barrel, nozzle, and hot manifold system. If this carbonized layer gets disturbed by temporary cold shutdowns, material changes, running wet material, etc., small pieces of it can break off, creating black specks in the molded lenses. To help avoid black specks, it is imperative that the barrel heaters should never be turned off during short- or long-term shutdowns. Instead, the heaters should be "banked" at 300°F – 320°F to avoid disturbing the carbonized layer and having small pieces of it detaching from the heated metal surfaces in the melt path.

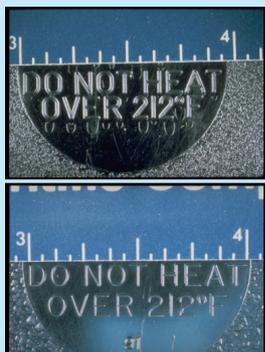
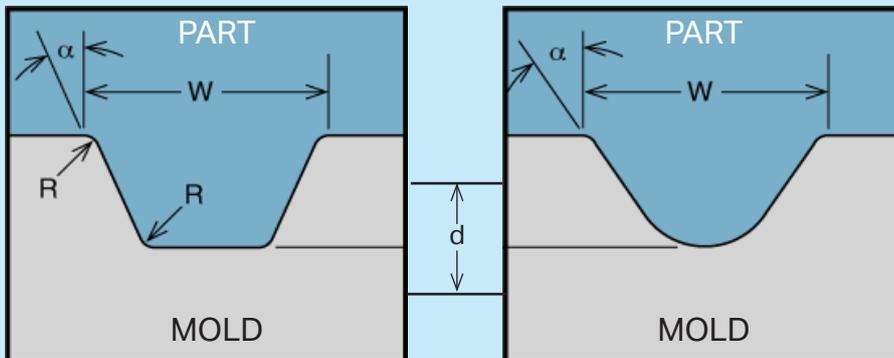
Flow marks at lettering locations

If proper design guidelines have not been followed when cutting letters and numbers into automotive lens molds, small flow mark defects can form as the melt fills the lenses and flows across these features. Refer to the guidelines below to avoid this problem.

$$\alpha \geq 30^\circ \quad W \geq 2d \quad d = 0.010\text{in (max)}$$

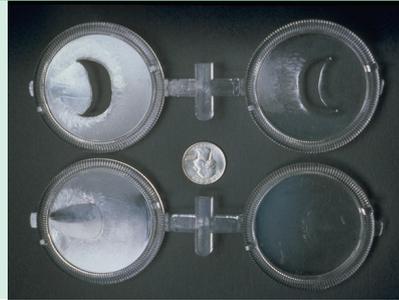
Air Entrapment

Some automotive lens designs are susceptible to air entrapment, which is caused by the melt "racetracking" around the outer perimeter of the part during filling and closing off the venting locations before all of the air has been pushed out of the part. While this problem should be discovered and corrected early on during mold filling analysis, sometimes it is not. To correct this issue, part wall thickness adjustments can usually be made, eliminating the air trapping.

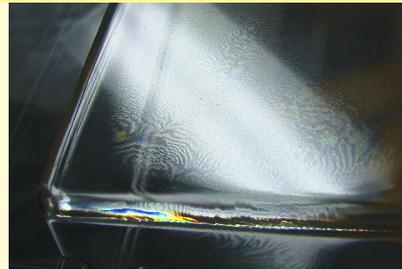
Cold Flow Ripples

This defect, sometimes called "record grooves," typically occurs when the melt flow front stalls out and is unable to fully pack out the part. Main causes for this defect include the melt temperature being too cool, mold temperature being too cool, filling speed too slow, insufficient packing pressure, insufficient wall thickness, insufficient venting, and gate size too small.

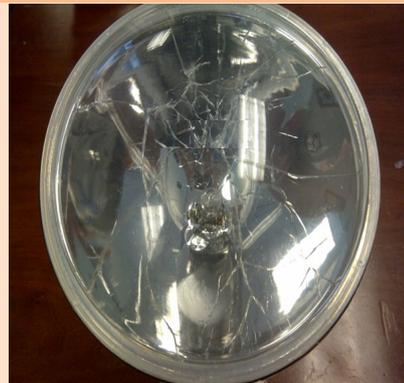
Brittle Parts

This defect can be caused by a number of different factors. Main causes include insufficient material drying, using too high of a melt temperature, too much material residence time in the barrel of the molding machine (barrel capacity too large for shot size) and using regrind that has been previously degraded.
