Tips for Defect-Free Injection Molding of TPU

1. Tips for defect-free injection molding of TPU

Various problems can arise when injection molding thermoplastics – and that goes for TPU, too. We have compiled an extensive list of possible defects, explained their causes and described preventive measures. To help you find them more easily, we have divided the defects into groups, such as “Defects caused by warpage” and “Defects caused by specks and dots”. Please do not hesitate to contact us if this list does not help you solve your problem.

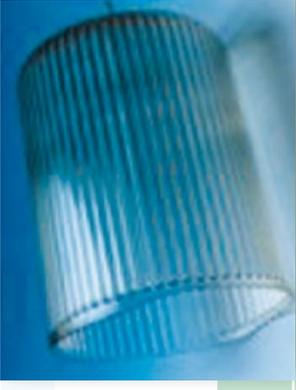
Short molding

Description: Molding not completely filled, mostly at end of flow path or thin-walled locations

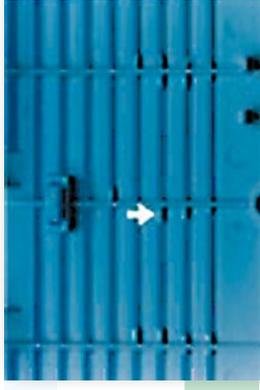
Flash

Description: Mold gap results in polymer melt penetration on molding

Permitted gap width exceeded. Locking force inadequate. Mold rigidity inadequate. Wear of sealing faces

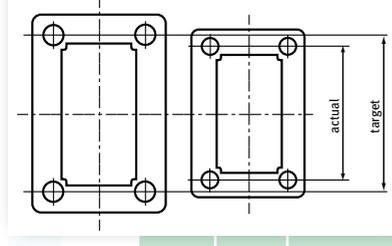
Variations in size

Description: Required dimensions of part not achieved

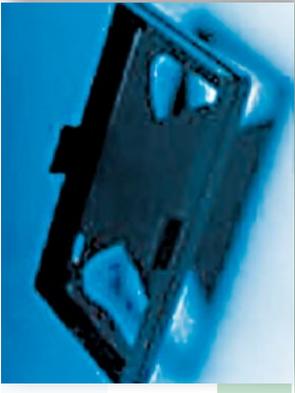
Variations in wall thickness (deviation between nominal and actual values)

Description: Thickness of molded part does not correspond to nominal value or varies greatly and is not within tolerance range

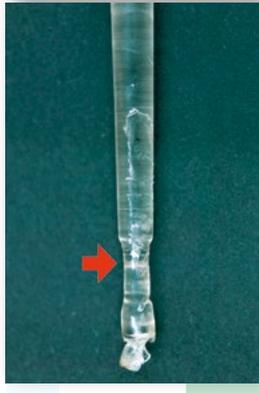
Sprue remains attached

Description: Sprue contracts and / or remains attached to sprue bush or cold runner

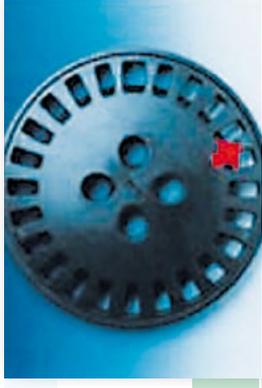
Ejector marks

Description: Distinct ejector marks on molding

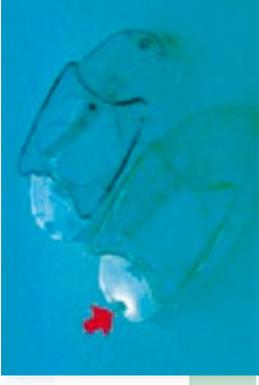
Molded part remains in cavity

Description: Molded part jams, cores / ejectors deform or penetrate part

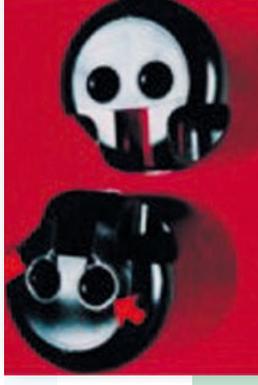
Description: Part deformed during removal

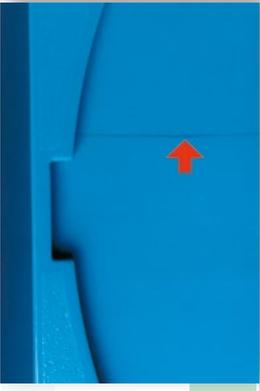
Darker color at weld lines

Description: Colored stripe. Darker color occurs at weld lines or near leading / lagging flow fronts fed from neighboring melt streams

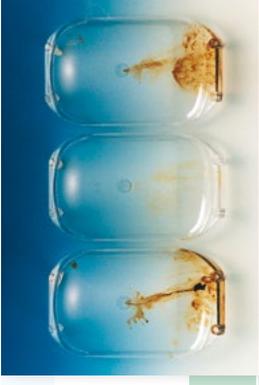
Black (overheating) marks

Description: Streaks and stains from burning, periodic discoloration, dark spots. Brown to black discoloration of molding, at different locations and irregular distances

Entrapped, compressed air in injection mold, resulting in burns

Optimize mold venting, in particular near flow lines and at end of flow path. Correct flow front (wall thickness, gate position or flow promoters). Check venting channels. Reduce clamping force. Evacuate mold

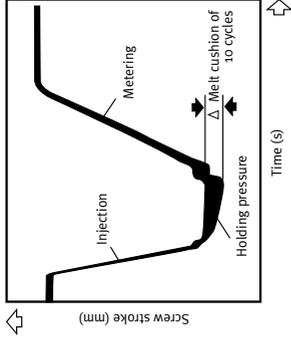
Melt cushion fluctuates

Description: Melt cushion varies greatly, sometimes approaching zero

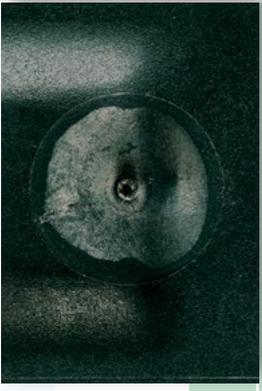
Matt surface defects at hot runner elements

Description: Rough, cracked surface, creating a matt effect close to hot runner elements or at hot cores

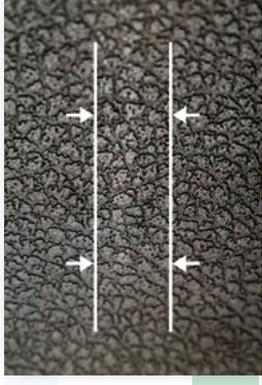
Damage to grain on molded part

Description: Cracked, rough surface with scoring in direction of removal (demolding), mostly at same location

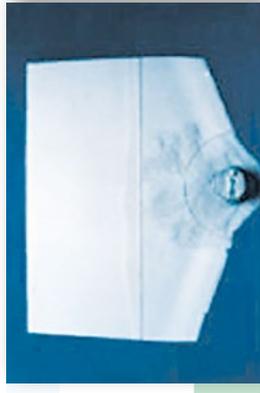
Flaking

Description: Cold displacement. Surface looks flaky with alternating shiny and matt areas, mostly near sprues

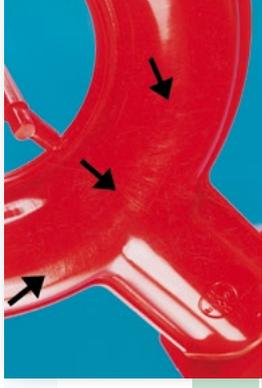
Streaks due to overheating, needle-like streaks

Description: Silver streaks. Elongated silvery streaks

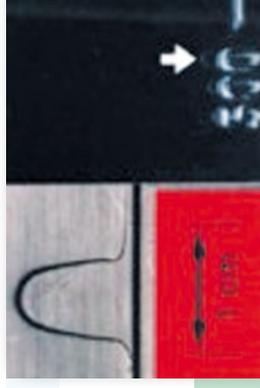
Tear drops

Description: Air-filled hook. Lines in shape of hook / tear drop caused by trapped air

Air rolled over and trapped in injection mold, e.g. from engravings, grooves or depressions

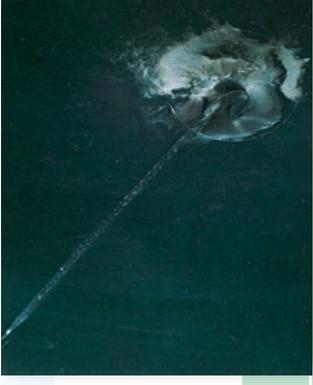
Cold slug

Description: Cold-flow mark. Well-defined, irregular matte area. Cold melt particles entrapped in surface of molding

| Causes: | Remedies: |
|--|--|
| Ejector claw on cold runner rod missing or too small to absorb cold slug | Provide or optimize ejector claw so that cold slug is absorbed |
| Melt leaking from machine nozzle or hot runner | Increase screw retraction, optimize thermal separation in hot runner |
| Nozzle aperture and heating inadequate | Make nozzle aperture larger, install band heater with higher capacity, check thermocouple and controller |

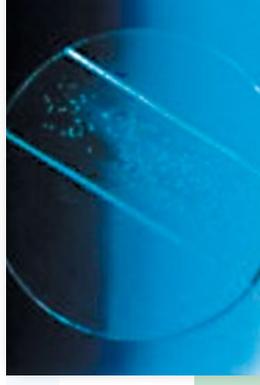
Small bubbles

Description: Entrapped air similar to voids but greater in number and with much smaller diameters

| Causes: | Remedies: |
|---|---|
| Material too moist | Check drying process |
| Unsuitable vented screw | Select appropriate vented screw or replace vented screw with normal one and pre-dry material N.B.: Fault often coincides with silver streaks. |

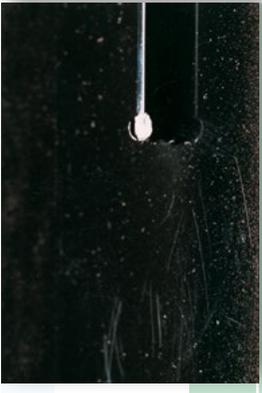
Craters

Description: Pinholes, pimples. Depressions the size of pinpricks

Material degradation

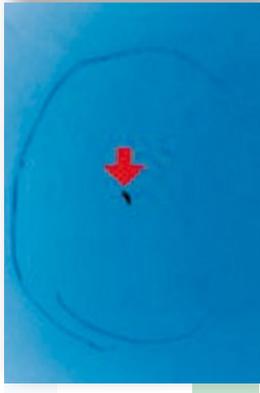
Gray dots

Description: Metal specks. Gray foreign particles which may appear shiny, depending on angle of light

Plasticating unit worn

Check plasticating unit for screw, cylinder or non-return valve wear
